BMC Australia

# Bulletin

C1/69

MG  
MIDGET

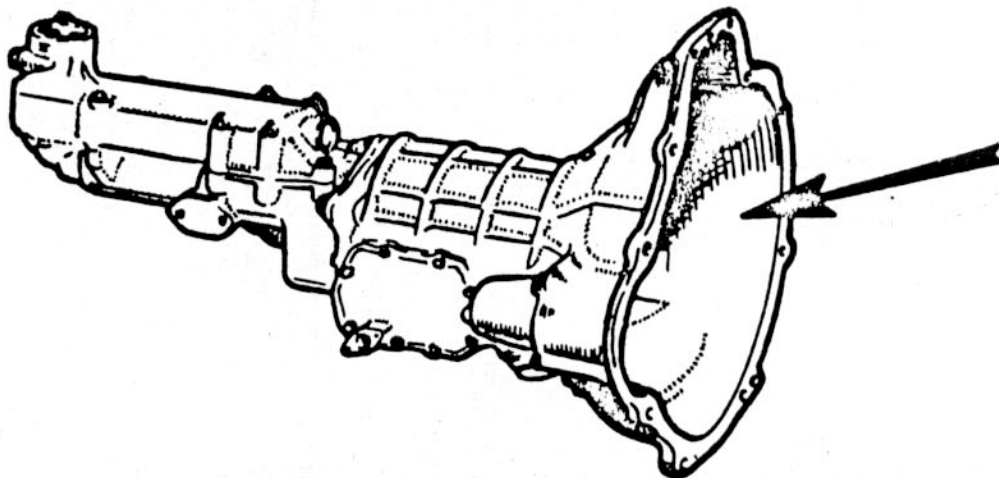
Difficulty in pulling up the gearbox to the engine may be due to the case assembly fouling the top left hand of the oil pump cover.

In such cases clearance should be given by removing a small amount of material from the inside of the casing where indicated by an arrow in the sketch.
