# Service bulletin

C  
231

THE BRITISH MOTOR CORPORATION (AUSTRALIA) PTY. LIMITED

## CARBURETTOR FLOODING AND FUEL STARVATION

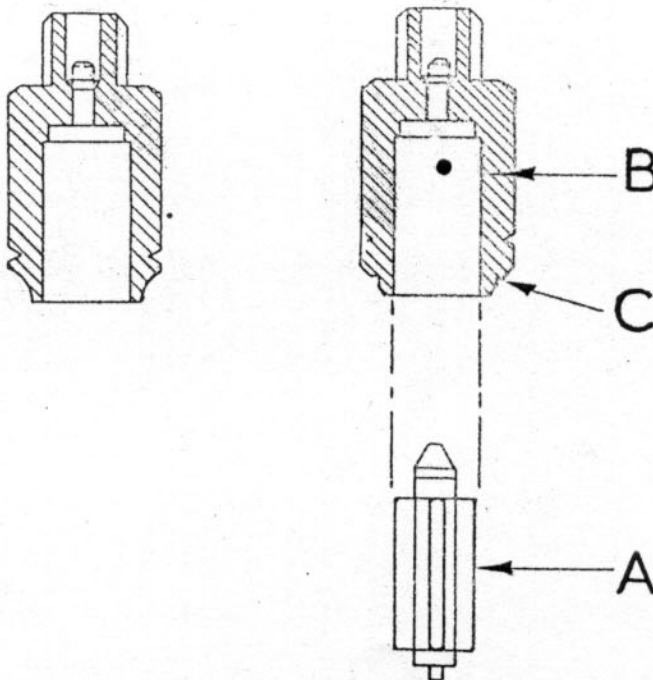
Instances of flooding and fuel starvation have been traced to the new type spring-loaded 'Delrin' float needle and seat assembly, Part No. AUD.9096. The needle body 'A' sticks against the walls of the seat 'B', owing to swelling of the nylon under the influence of certain fuels.

To obviate this trouble the seat bore has been increased from .2445" to .2475"/.2485, groove 'C' having been added to the needle seat to enable the modified assembly to be readily identified.
