Service bulletin

C. 269

MISFIRING, SURGE & CARBURETTER FLOODING

HEALEY
SPRITE
(Mark IIA)

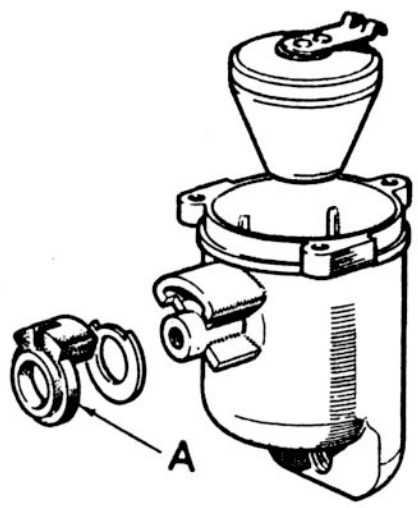
Some engines suffer certain vibrations, even though they may be to a good standard of balance, and this may produce surge and misfiring on pick-up and during light throttle cruising.

Such faults may be prevented by changing the carburetter rubber grommets 'A' to Part No. AUD 2676 (front) and AUD 2677 (rear). Additionally, carburetter needles should be changed from GY to AN.

If flooding has been occurring, new float chamber needles and seats should be fitted, as the existing ones may have become ridged.
