Service bulletin

THE BRITISH MOTOR CORPORATION (AUSTRALIA) PTY. LIMITED

GEARBOX MOUNTING

AUSTIN
HEALEY
SPRITE
MK. III

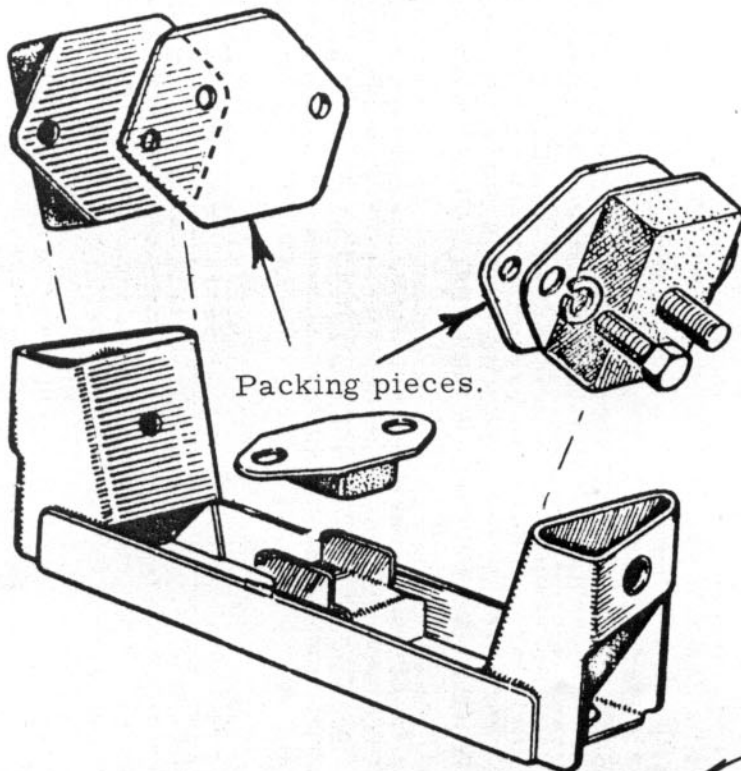
Certain complaints of engine vibration and harshness have been traced to the gearbox rear extension resting on the rear mounting support.

This condition may be rectified by inserting packing pieces, Part No. 2A 5423, between the mounting assembly and the gearbox rear extension, as incorporated in production from the following change-point:

Austin Healey Sprite Mk. III Car No. 48403.
